**THE STRUCTURAL STABILIZATION OF THE NEW YORK STATE PAVILION
LOCATED IN FLUSHING MEADOW CORONA PARK, BOROUGH OF QUEENS,
KNOWN AS CONTRACT NUMBERS Q099-1695 TO Q099-1995
DESIGN CONTRACT NUMBER CNYG-195**

**JOHN CIARDULLO ASSOCIATES
ARCHITECTS/PLANNERS
41 WEST 57TH STREET
NEW YORK, N.Y. 10019**

October 2, 1996

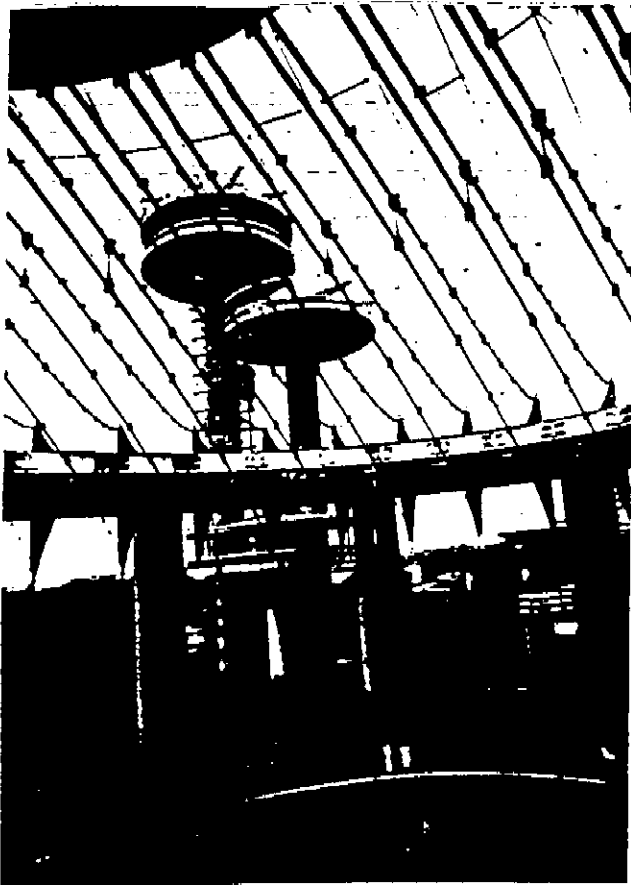
5) The worst visible damage that has occurred to the cable roof structure is that damage found at the compression ring lower cable attachment points. The action of weather and bird debris at these points may be magnified due to the fact that any precipitation landing on the lower cable runs off at these points. The damage noted at these locations is more severe corrosion than can be found anywhere else on the cables and it has progressed to the point where one or more of the exterior cable strands in each cable bundle have completely failed at approximately 27 of the total 48 of these connections. At the two locations where a close inspection was made, approximately 9 to 12 of these strands had completely failed. This may represent an approximately 6% to 10% of the total cable thickness. Although these lower cables do not directly support the roof structure, they are necessary for the stability of the structure and are necessary to maintain the current shape and the equilibrium of all forces in the tensile structure. In this capacity, these cables are maintained under a considerable amount of tension at all times.

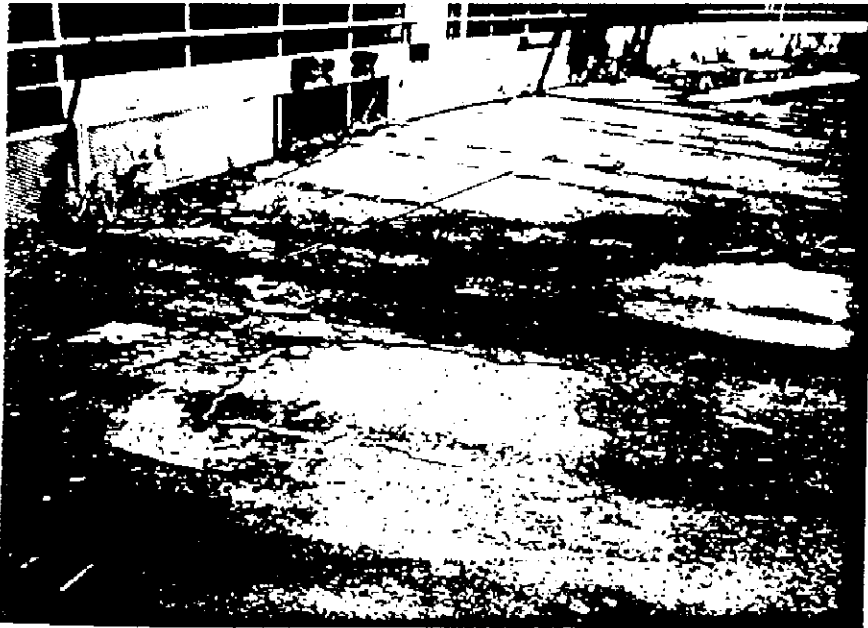
3. Peeling membrane with weed infiltration

- The roof promenade structure is a concrete slab on a steel deck. The top of the slab has been coated with an asphaltic wearing surface. This asphaltic surface has alligatored, peeled up, chipped off and has generally worn out at many locations.
- Inspection of a section of lifted asphalt shows that at one time it was directly adhered to the concrete deck. There is no indication that there was any insulation or other waterproofing compounds used on this level.
- The asphalt surface at the roof promenade has settled and large depressions have formed that now retain water. The existing drainage structures are clogged and not maintained, if they are still intact, and do not adequately serve the roof. In some locations, water has penetrated the promenade and completely rotted out the steel deck.

- Replace existing wood piles with steel piles.
- Completely remove existing asphalt roof to concrete deck.
- Cut out and replace damaged areas where metal deck has corroded or failed.
- Install roof insulation, roofing membrane, flashing and ballast in either an IRMA or standard built up roof configurations. The choice of roof system depends upon whether access to the roof is anticipated or required.
- Remove entire building, columns, walls floors and pile caps to 36" below grade.
