**THE STRUCTURAL STABILIZATION OF THE NEW YORK STATE PAVILION
LOCATED IN FLUSHING MEADOW CORONA PARK, BOROUGH OF QUEENS,
KNOWN AS CONTRACT NUMBERS Q099-1695 TO Q099-1995
DESIGN CONTRACT NUMBER CNYG-195**

**JOHN CIARDULLO ASSOCIATES
ARCHITECTS/PLANNERS
41 WEST 57TH STREET
NEW YORK, N.Y. 10019**

October 2, 1996

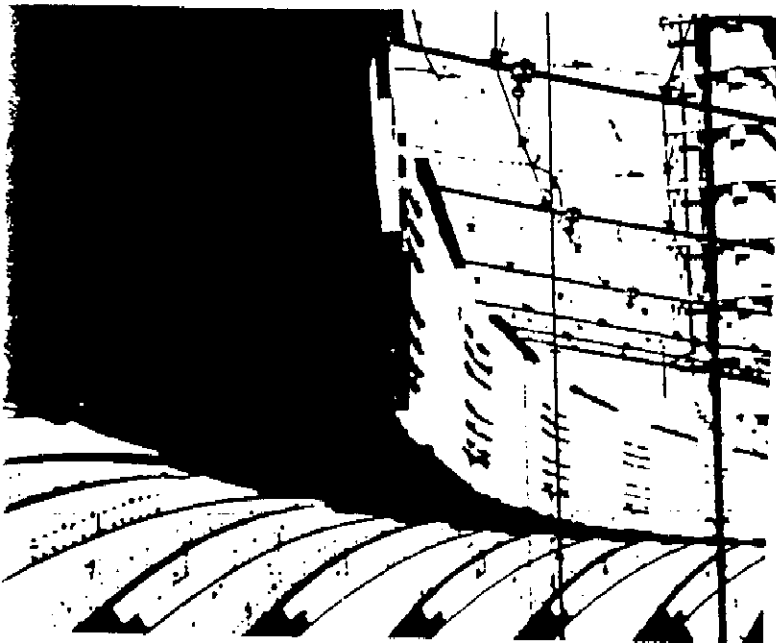
- 4) The upper cables and their anchor points are in fair condition. however, it was noted that the entire length of the bottom of this cable is red with rust colored stains. This indicates that this cable as well as the lower cables have lost their galvanized coating in some places and have been subject to corrosion for some time. This indication of interior rust casts some doubt on the cable's ultimate capacity. It would be prudent to assume that these cables have a diminished capacity at this point and to replace these cables if a roof structure will be attached to it. Unlike the lower cable connections, no broken strands were noted at the two top cable connections inspected with the boom crane or at those inspected from the ground with binoculars. This could be due to the fact that precipitation flows down the cables away from the exterior anchor points as well as from the connections to the central tension ring.

5) The worst visible damage that has occurred to the cable roof structure is that damage found at the compression ring lower cable attachment points. The action of weather and bird debris at these points may be magnified due to the fact that any precipitation landing on the lower cable runs off at these points. The damage noted at these locations is more severe corrosion than can be found anywhere else on the cables and it has progressed to the point where one or more of the exterior cable strands in each cable bundle have completely failed at approximately 27 of the total 48 of these connections. At the two locations where a close inspection was made, approximately 9 to 12 of these strands had completely failed. This may represent an approximately 6% to 10% of the total cable thickness. Although these lower cables do not directly support the roof structure, they are necessary for the stability of the structure and are necessary to maintain the current shape and the equilibrium of all forces in the tensile structure. In this capacity, these cables are maintained under a considerable amount of tension at all times.

- 4) Repair to cables will be the most significant cost in the stabilization/reconstruction project for the superstructure of the pavilion. The process for cable removal and replacement will require careful consideration. Sequencing the cable removal and replacement for the removal of opposing cables simultaneously in order to maintain equilibrium in

the structure once cable replacement begins. Failure to consider this in cable replacement will result in deformation of roof structure and changes in the shape of the compression ring. As a part of this process, all of the auxiliary and tie cables will be removed and replaced and both the upper and lower cables removed and replaced. Alternatives to total cable replacement may be considered if future plans for the pavilion do not include installation of a complete roof. Partial replacement of the most damaged lower cables and redesign of cable anchors to re-attach the sound ends of the existing cables to the fluted ends of the compression ring may be possible however, these alternative solutions would require careful design and could theoretically provide the least expensive method of reconstruction. However, any of these options would require careful study and procedural innovation to keep reconstruction costs down.

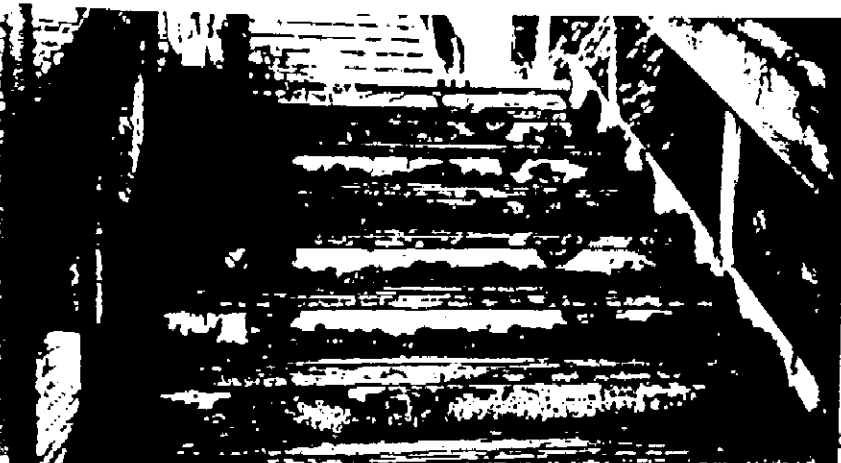
3. Peeling membrane with weed infiltration

- The roof promenade structure is a concrete slab on a steel deck. The top of the slab has been coated with an asphaltic wearing surface. This asphaltic surface has alligatored, peeled up, chipped off and has generally worn out at many locations.
- Inspection of a section of lifted asphalt shows that at one time it was directly adhered to the concrete deck. There is no indication that there was any insulation or other waterproofing compounds used on this level.
- The asphalt surface at the roof promenade has settled and large depressions have formed that now retain water. The existing drainage structures are clogged and not maintained, if they are still intact, and do not adequately serve the roof. In some locations, water has penetrated the promenade and completely rotted out the steel deck.

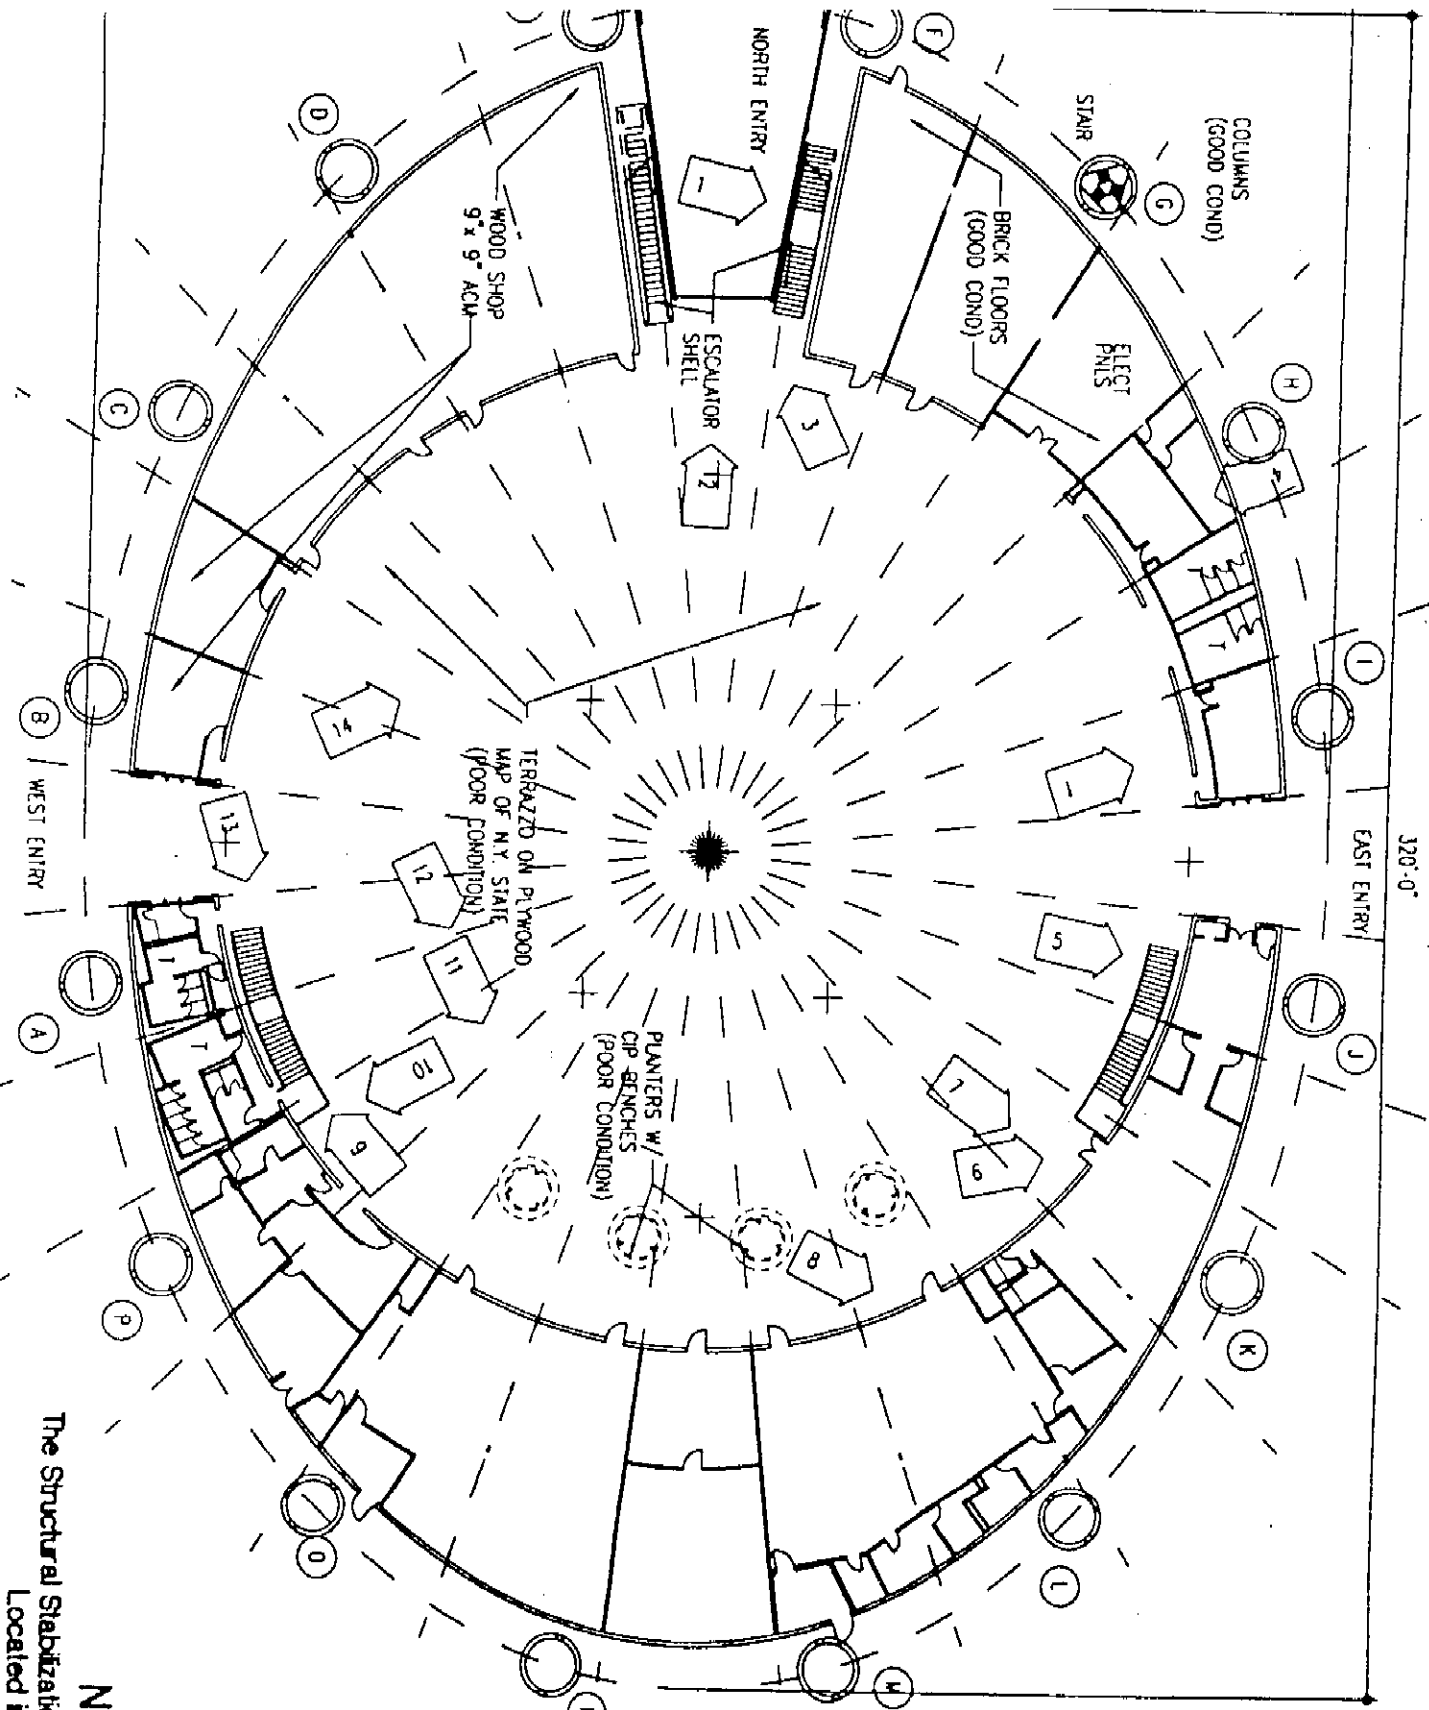
- PHOTO NO. DESCRPTION
- 1- ROTTED STAIR
 - 2- VIEW UP STAIR
 - 3- RUSTED S
 - 4- ELEC PANEL
 - 5- SIDE STAIR
 - 6- UNDERSID PLATFORM IN ADJAC
 - 7- CRACKED INTERIOR
 - 8- MASONRY & DISLOC
 - 9- UNDERSID PLATFORM
 - 10- DAYLIGHT
 - 11- CLOSE UP PLYWOOD TERRAZZO
 - 12- MAP OF 1 CRACKED WEEDS
 - 13- VIEW UP STAIR

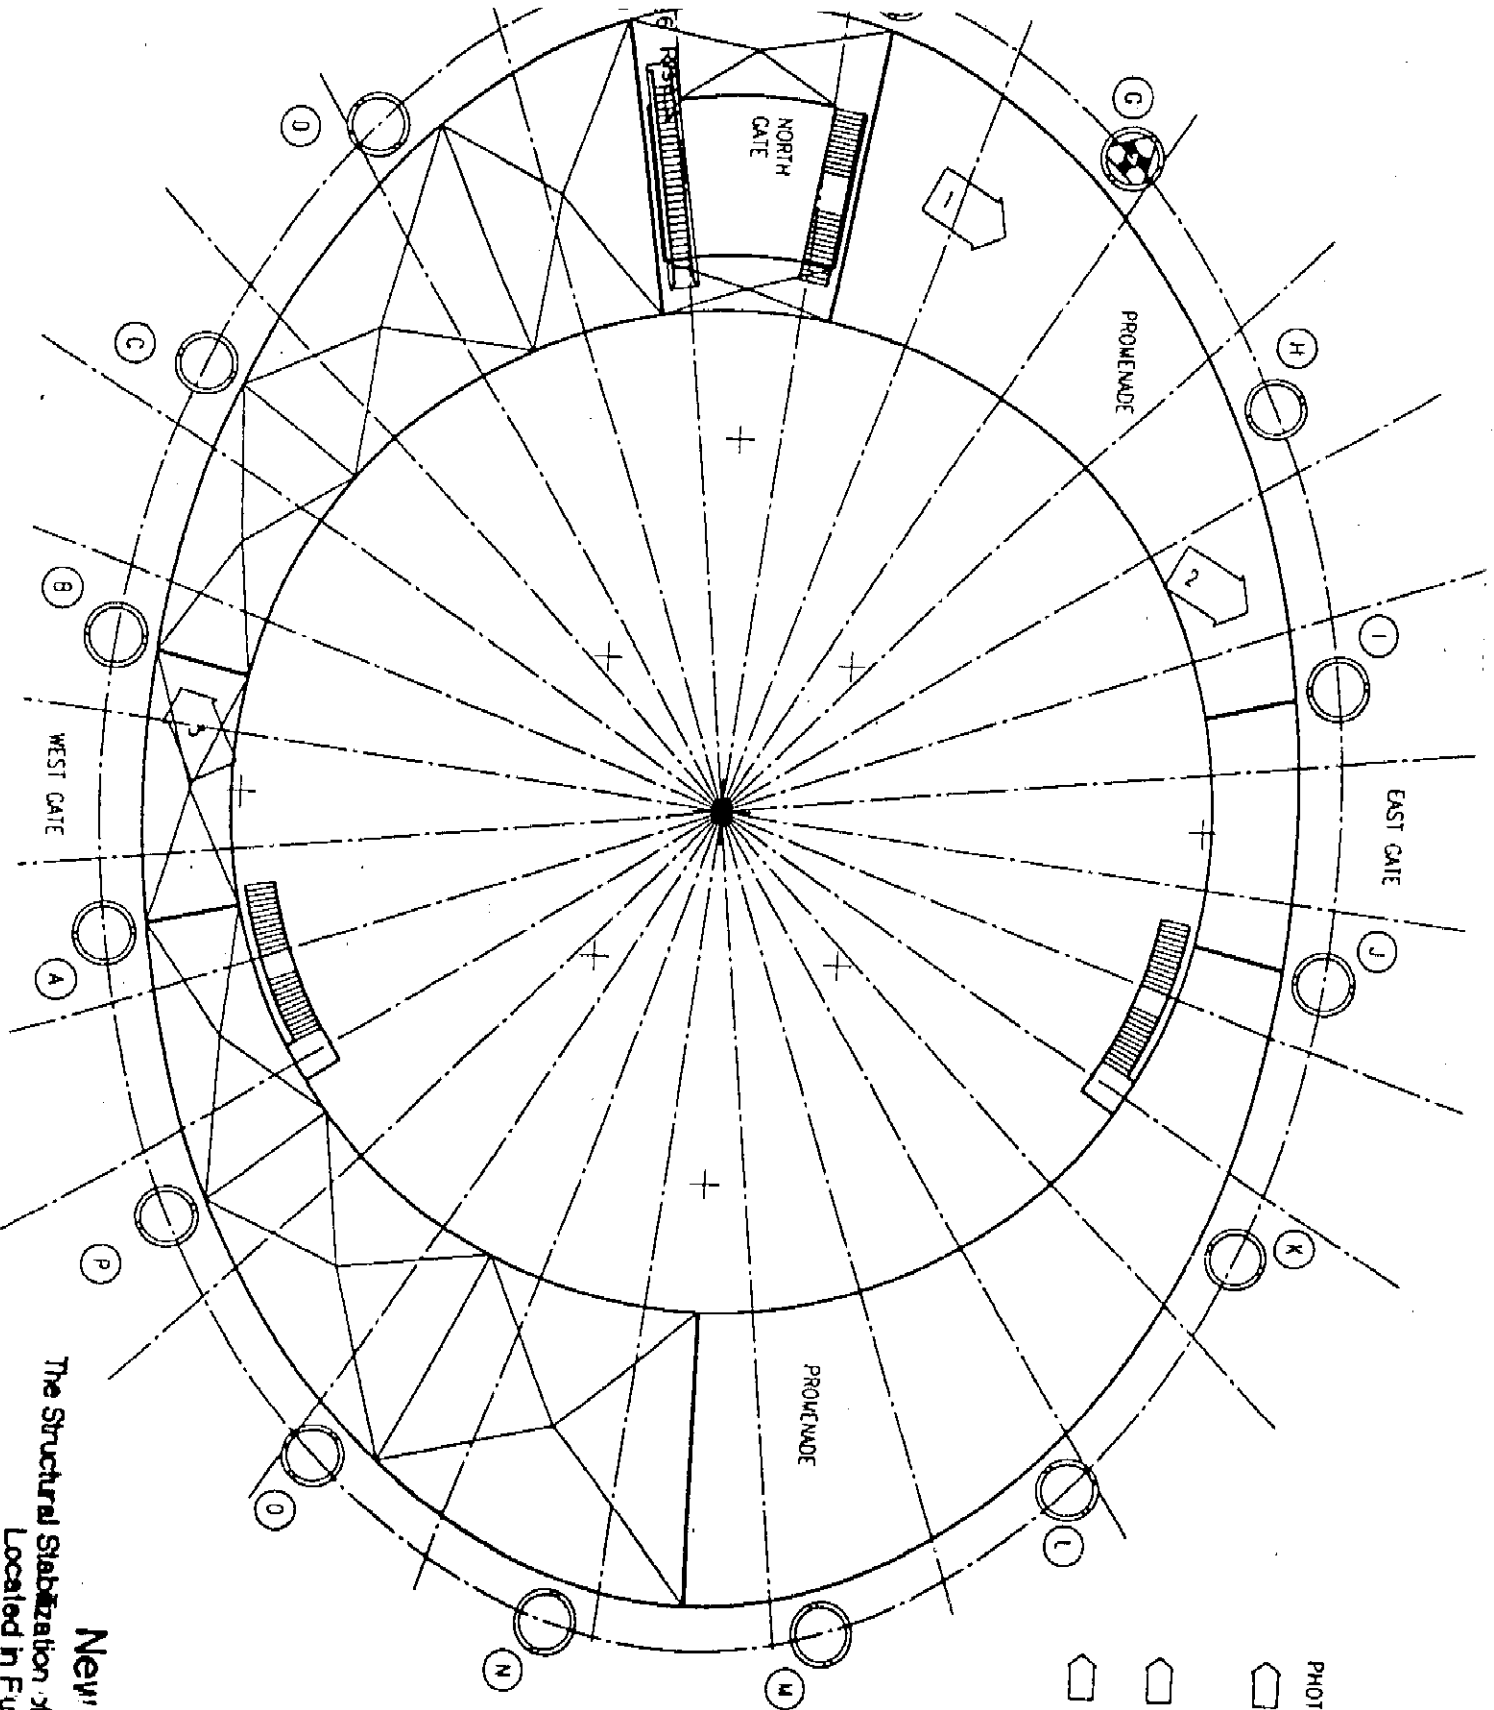
- PHOTO NO. DESCRIPTION
- 1- ROOF PROMEN
ASPHALT MEW
AREAS OF PO
 - 2- ASPHALT ROO
CONC DECK
 - 3- PEELING WEVB
INFILTRATION
